PHASE I INSPECTION REPORT  
NATIONAL DAM INSPECTION PROGRAM

WHITEWATER BROOK DAM NO. 2

NH 00344

Identification No.: NH 00344  
Name of Dam: Whitewater Brook Dam No. 2  
Town: Claremont  
County & State: Sullivan, New Hampshire  
Stream: Whitewater Brook  
Date of Inspection: June 7, 1978

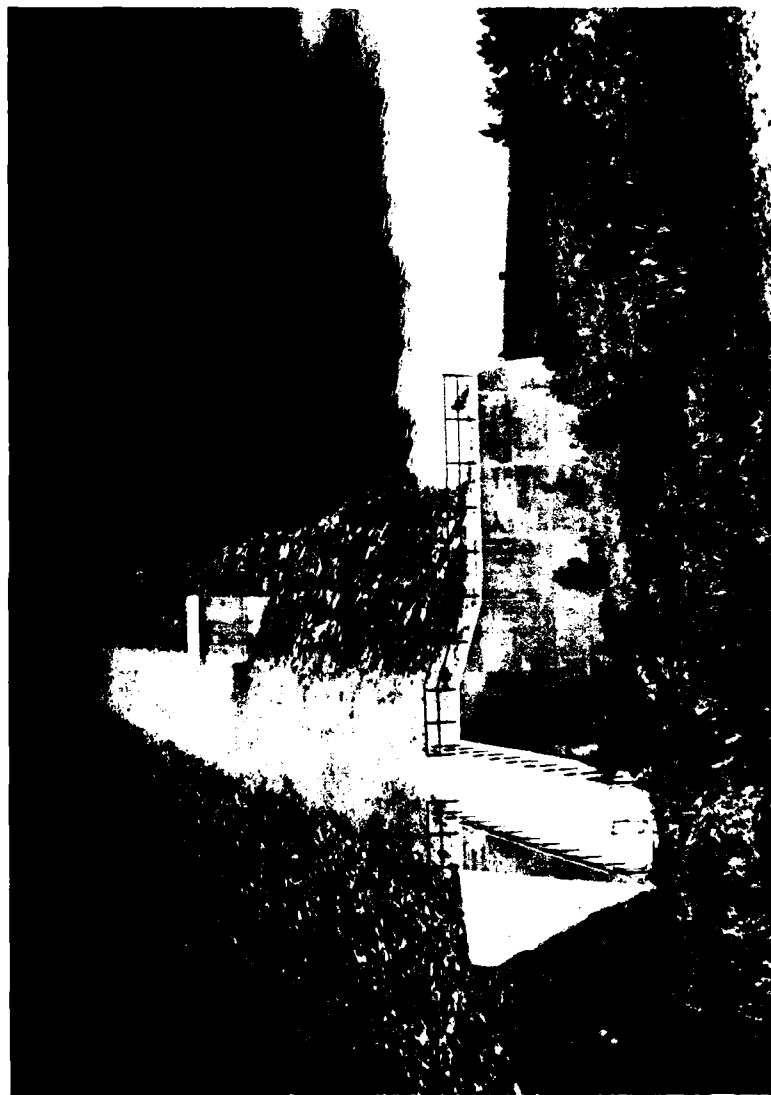
WHITEWATER BROOK DAM NO. 2, LOOKING WEST  
Negative No. 6-30A

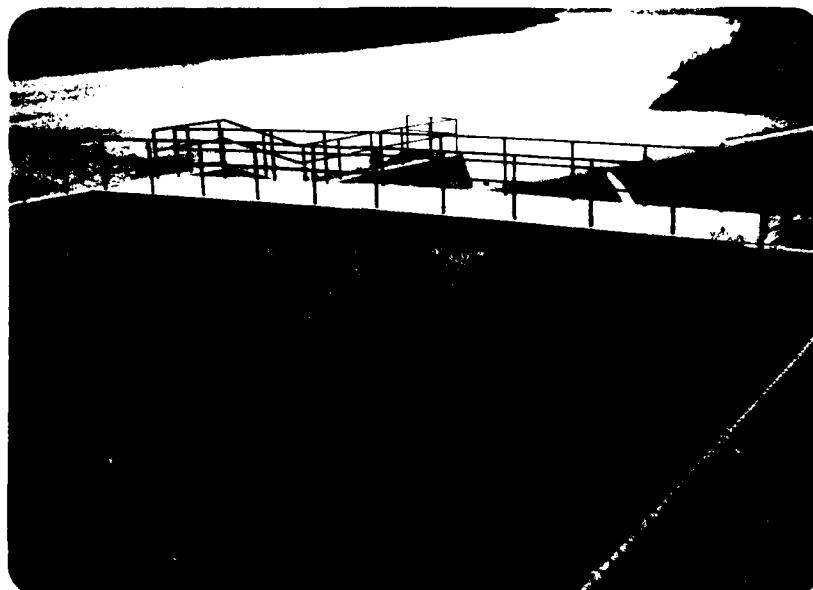
alignment is generally good, and no erosion or cavitation was noted. Patches of the concrete were observed on the downstream face of the spillway. The footbridge was constructed using both precast and cast-in-place concrete. The railing of the bridge, consisting of 1 1/2-inch pipe, was observed to be in good condition (Photographs No. 3, 4, 7, 8, and 13, Appendix C).

7. Service Bridge, Looking North, Showing West Abutment.

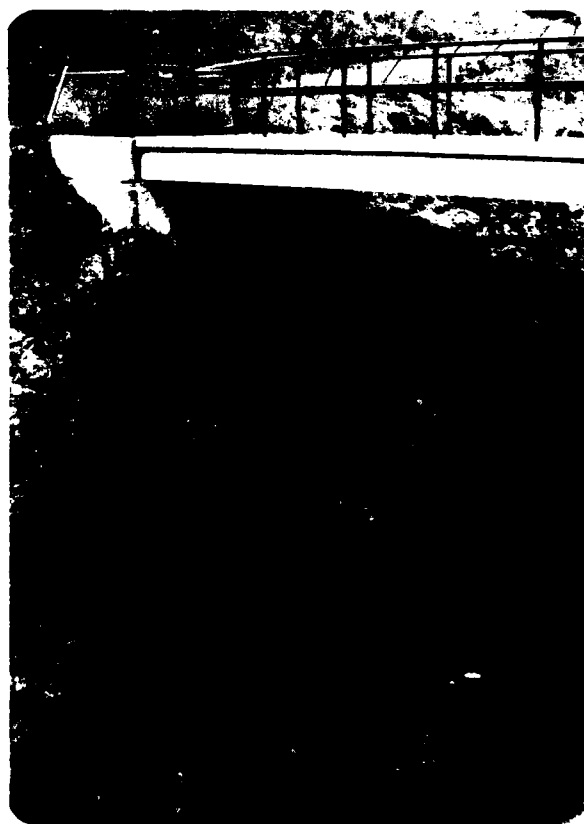
8. East Abutment of Service Bridge.
